Computer-Aided-Design and Manufacturing of Full Mouth Restoration of a Male Patient with Gastroesophageal Reflux Disease: A Case Report

Modern dentistry increasingly concentrates on digital procedures, including computer-aided-design and computer-aided-manufacturing (CAD/CAM) technology and the development of fixed and removable prostheses based on millable materials. This case-report presents a case of a 67-year-old male having a chronic gastroesophageal reflux disease (GERD) with severe abrasion of upper anterior teeth and loss of bone in edentulous areas. Evaluating the possible modalities of treatment and the associated empirical evidence. In addition, the full mouth rehabilitation with a minimally invasive procedure using veneers on the lower anterior teeth, CAD/CAM restorations on the remaining teeth, and implant-supported fixed dental prostheses in the edentulous areas were chosen considering the patient's factors such as tooth prognosis, wishes and economic status. Accurate diagnosis, ideal occlusal design with a 3D virtual implant planning and use of contemporary restorative materials can ensure favorable functional and esthetic rehabilitation for long-term prognosis.

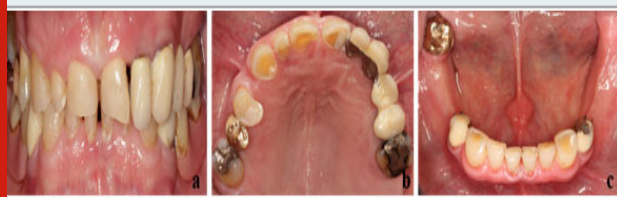
The patient's state of dental hygiene was average. Intraoral assessment of the patient exhibited inharmonic teeth forms and multiple diastemata. The upper central incisors and canines were massively short indicated severe abrasion and the vertical dimension of occlusion (VDO) was also affected (Fig. 1a). The horizontal and vertical bone loss was also diagnosed in edentulous areas. Several deficient crowns and fixed dental prostheses (FDPs) were identified as a result of poor marginal closure, as well as a deficient mandibular removable dental prosthesis (RDP) (Fig. 1b and 1c).

Figure 1: Patient's preoperative images: (a) close-up view of the smile; (b) intra oral maxillary view with erosion and attrition; and (c) intra oral mandibular view with erosion and attrition.

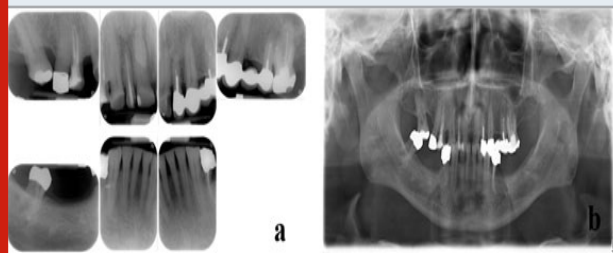
The radiographic assessment showed insufficient root canal fillings on teeth 5,7,10,13,19,21 and apicectomy on teeth 13, 14; and a transverse fracture in the cervical root part of tooth 21 and a mesiodens (Fig. 2a & 2b). The patient was diagnosed with the minor facial asymmetry toward left, multiple insufficient restorations, generalized gingivitis, multiple insufficient root fillings, horizontal root fracture on tooth 34 and compromised esthetics.

Figure 2: Patient's radiographic analyses: (a) periapical x-rays of maxillary and mandibular teeth showing dental wear in the anterior region and insufficient restorations; and (b) panoramic x-ray showing insufficient root canal fillings on teeth 14,12,22,25,36,34, apicectomy on teeth 25, 26, a transverse fracture in the cervical root part of tooth 34 and a mesiodens.

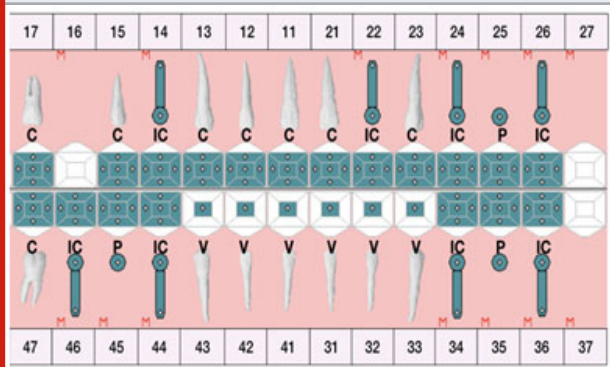
Figure 3: Final treatment plan with a minimally invasive procedure using veneers (V) on the lower anterior teeth, CAD/CAM restorations on the remaining teeth (C), and implant-supported fixed dental prostheses in the edentulous areas (IC: implant-supported crown, P: pontic, M: Missing).

After evaluating the possible treatment modalities and the related scientific evidence, as well as considering the patient's factors such as tooth prognosis, wishes and economic status. The full mouth rehabilitation with a minimally invasive procedure using veneers on the lower anterior teeth, CAD/CAM restorations on the remaining teeth, and implant-supported fixed dental prostheses in the edentulous areas were selected (Fig. 3).

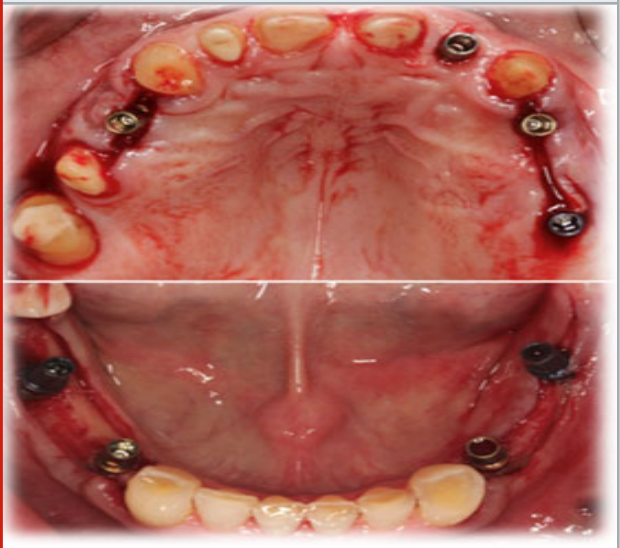
Figure 6: Intraoral occlusal views immediately after implant placement in the mandible and in the maxilla.

The data were uploaded to the production center, where the fabrication of the surgical guides took place. Using surgical guides, together with a guided surgery kit (Xive surgical kit GS, Dentsply Implant Manufacturing GmbH, Mannheim, Germany), the implants were placed in two separate surgical appointments (Fig. 6). Tooth 5 were placed with an internal sinus lift. Four months after placement, second-stage surgery was performed and healing abutments were fixed onto the implants. After definitive preparation of the abutment teeth, a double cord technique was used for the displacement of the gingival tissues. The implant transfer impression copings were mounted onto the implants and their position was controlled radiographically.

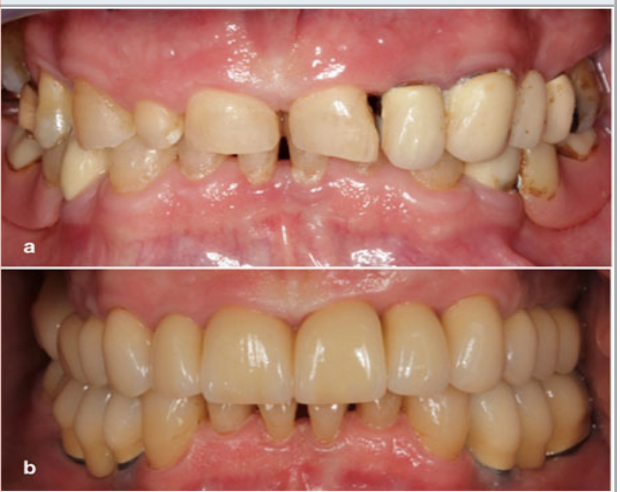
Figure 7: Intraoral frontal view: (a) Pre-treatment and (b) Post-treatment.

jaw relation records. Next, fabrication of the individual implant abutments using computer aid design CAD (DentalDesigner™, 3shape dental system) was performed. All teeth received monolithic lithium disilicate crowns (e.max), which were adhesively cemented. Layered zirconia crowns were fabricated for the custom implant abutments, which were horizontally screwed. At the one-week follow-up, the patient was satisfied with his new restorations, and a protective night guard was delivered at that time. To improve long-term prognosis, the patient entered a 4-month recall maintenance program and had been followed for 2 years (Fig. 7).
